# Manhole Inspection Summary

Manhole # S43II\_031MH

Insp Date: **3/1/10 1:38 PM**

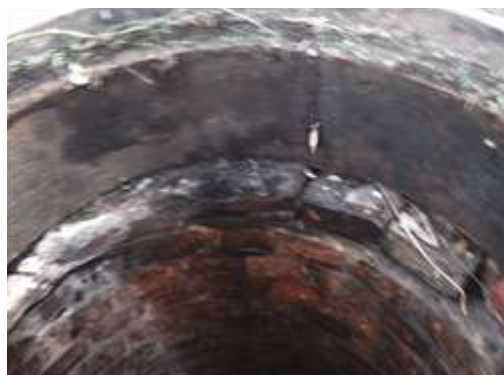
Defect 3

Condition: ☐ Sound ☐ Cracked ☐ Root Intrusion ☒ **Loose Brick** ☐ Deteriorated

loose bricks

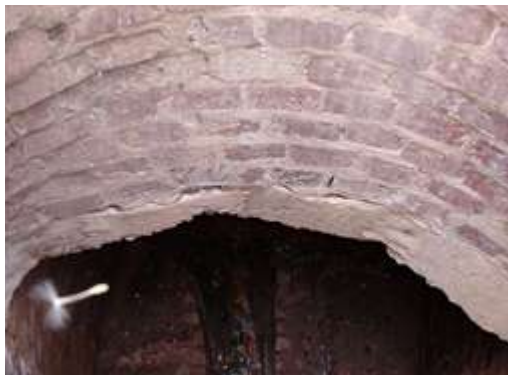
Defect 1

infiltration

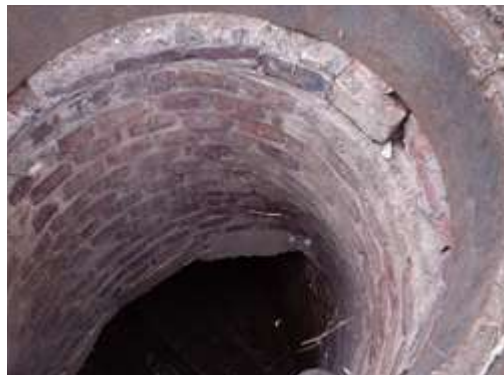
Defect 2

loose bricks

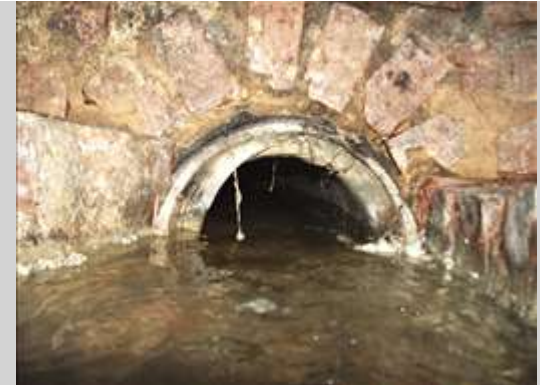
8 in. Circular Gravity Sewer  
Pipe Out @ 12 O'Clock

Pipe Height: **12** (in.) Rod and Bar (Angled)  
Pipe Material: **Clay** ☐ Pipe Lined  
Invert Depth: **9.58** (ft.) Flow Characteristics: **Fast**  
Deposits: ☒ None ☐ Mud ☐ Sludge ☐ Debris ☐ Grease  
Silt Depth: (in.) Deposits Extent:  
Infiltration: **None** Pipe Seal Cond: **Sound**

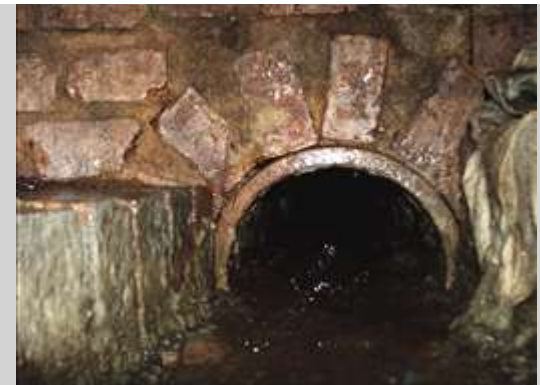
8 in. Circular Gravity Sewer  
Pipe In @ 6 O'Clock

Pipe Height: **12** (in.) Rod and Bar (Angled)  
Pipe Material: **Clay** ☐ Pipe Lined  
Invert Depth: **9.83** (ft.) Flow Characteristics: **Fast**  
Deposits: ☒ None ☐ Mud ☐ Sludge ☐ Debris ☐ Grease  
Silt Depth: (in.) Deposits Extent:  
Infiltration: **None** Pipe Seal Cond: **Sound**

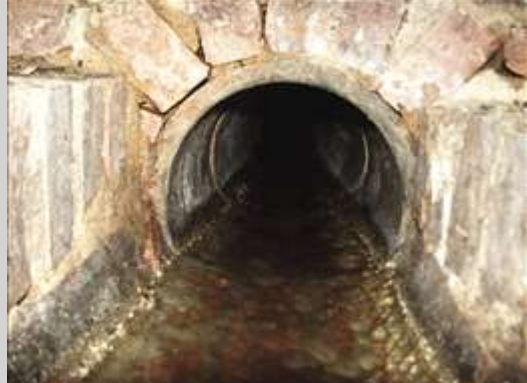
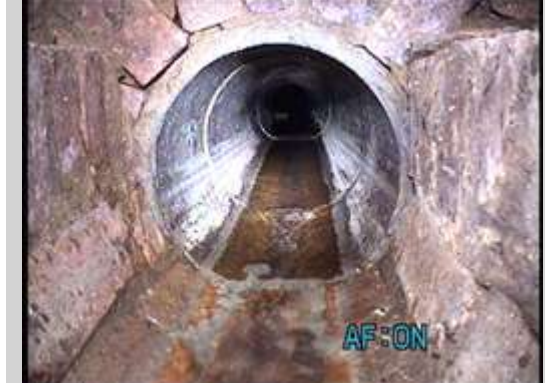
Pipe In @ 9 O'Clock

Pipe Height: **8.4** (in.) Rod and Bar (Angled)

Pipe Material: **Clay** ☐ Pipe Lined

Invert Depth: **8.90** (ft.) Flow Characteristics: **Fast**

Infiltration: **None** Pipe Seal Cond: **Sound**
